e-Journal of New World Sciences Academy  
2010, Volume: 5, Number: 4, Article Number: 1A0113

**Sevgen Perker**  
**Nilüfer Akıncıtürk**  
Buras University  
zsperker@gmail.com  
Bursa-Turkey

**THE PROBLEM OF ADOPTING TRADITIONAL HOUSE FOR TODAY: EXAMPLE OF BURSA**

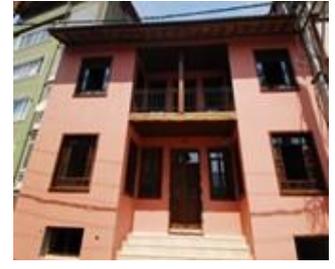
Table 2. The situtation of example 2, before and after the renewal [9]  
 (Tablo 2. Örnek 2'nin yenileme öncesi ve yenileme sonrası durumu)

The building, which is known as 'Gurabahane - i Laklakan', is located next to the İRGandı Bridge in Osmangazi Centre town of Bursa. The construction; that is one of the Ottoman Period examples and was opened as the first stork hospital of the world, is composed of three storeys. After the construction; the building was divided into two and there occurred some space and structure changes. It is known that in the original situation of the building; there were service spaces on the basement floor and there were living spaces on the other floors. The basement floor walls were constructed by cluttered stone with mud plaster technique and the ground floor and the top floors were constructed with timbered skeleton technique (filled with adobe and brick). The layers and the ceilings were formed with wooden materials. The wooden roof construction of the building is covered with tiles and the doors and the windows are all wooden [9].

Today; the function of this building was transformed to a day care centre for kids. The main goal of this renewal is to protect and open it as a day care centre. Within this; a new entrance hole, a cellar a kitchen and a laundry space were designed for the basement floor and three toilets were added to the building. On the ground floor; a new room was added from the outer side and the vertical separation was removed. On the first floor; the vertical separation was also removed and two new spacious rooms were acquired by uniting the two rooms of each of the two directions. Some actual service systems were integrated to the building. It is seen that within the adaptation period, the construction was integrated new clean and fithy water and electricity and heating and air conditioning installation Table 2 [9].

Basement Floor Plan	Ground Floor Plan	1st Floor Plan	General View [12]

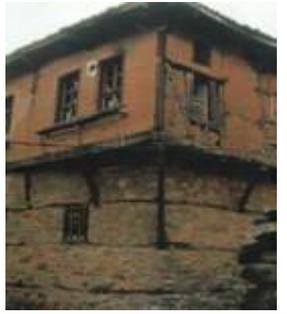
Table 5. The situation of example 5, before and after the renewal [9]  
 (Tablo 5. Örnek 5'in yenileme öncesi ve yenileme sonrası durumu)

The building, which is one the rural architecture examples of the Ottoman Empire Period, is located in Cumalıkızık district of Bursa. This is a three-storey house having service spaces on the basement floor and living areas on the top floors. The base and mid-floor walls were constructed with a technique of mud plastered stone cluttering and the topfloor walls were constructed with adobe filled wooden skeleton technique. The layers and the ceilings and window/door elements are all wooden. The roof system of the building was formed with Turkish style on wooden construction and covered with tiles.

The purpose of this renewal is to preserve the building similar to its origin and to open itto service as a restaurant. Within the extent of this renewal it was proposed that a part of the space - used as a depot or stable - on the basement floor would be used as the kitchen of a restaurant. The other part of that space could be used as the heating system centre and depot. Two toilets were added to the basement and the rooms on the first and second floors and the hole of the second floor were suggested to be used as restaurants. The construction was integrated new clean and fithy water and electricity and heating and installation within the extent of this adaptation. Table 5 [9].

Basement Floor Plan	1st Floor Plan	2.nd Floor Plan	General View 15]
<b>SITUATION AFTER THE RENEWAL</b>
